**Flood Control Project Maintenance  
Levee Inspections****LMA District Cover Sheet****Spring 2012 Levee Inspection Results****Solano County Public Works Mellin Levee**

**Spring 2012 Levee Inspection Results**

**Solano County Public Works Mellin Levee**

**Levee Inspection Report By Mile - Spring 2012**

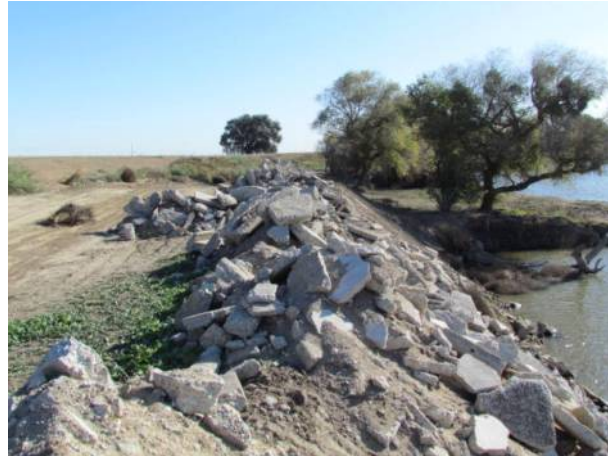
Levee Mile Report Line	4
Start Levee Mile	0.00
End Levee Mile	0.00
Location	Water Side
Category	Earthen Levee
Item	Vegetation

Looking northeast at bamboo on waterside at the entrance to levee.

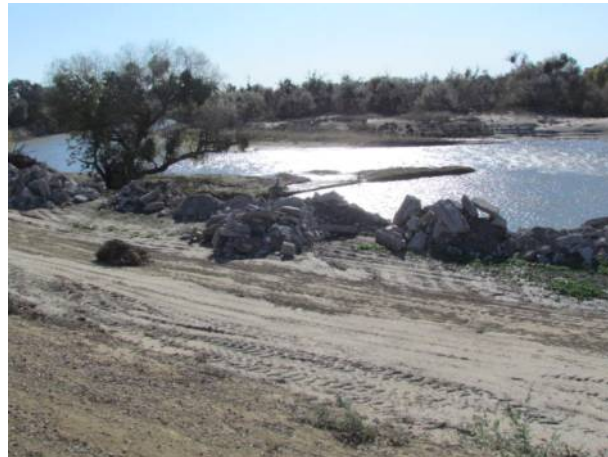
Levee Mile Report Line	4
Start Levee Mile	0.00
End Levee Mile	0.00
Location	Water Side
Category	Earthen Levee
Item	Vegetation

Looking west at bamboo on waterside slope.

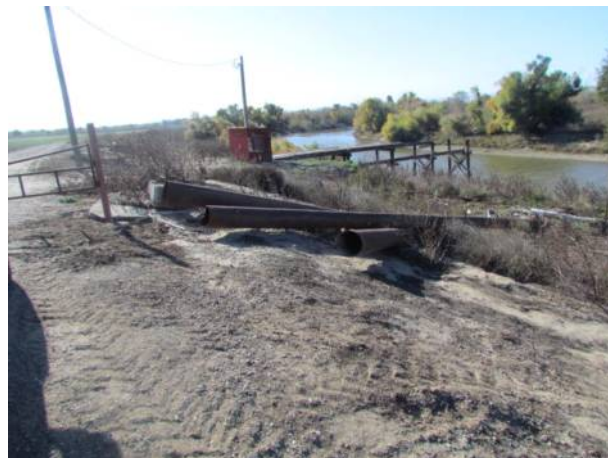
Levee Mile Report Line	6
Start Levee Mile	0.00
End Levee Mile	0.59
Location	Water Side
Category	Earthen Levee
Item	Encroachments

DWR ID: DWR_NA0012_01_s_2012_2										
6	0.00	0.59	Earthen Levee	Encroachments	WS	M En	FE : Fences	38.174167 ° -121.674312 °	38.178960 ° -121.680600 °	3 Y
DWR ID: DWR_NA0012_01_s_2012_3										
7	0.04	0.04	Earthen Levee	Encroachments	LS	M Ma	AV : Abandoned vehicles	38.174470 ° -121.674730 °	38.174470 ° -121.674730 °	8 Y
DWR ID: DWR_NA0012_01_s_2012_8										
8	0.10	0.28	Earthen Levee	Encroachments	LS	M En	FE : Fences	38.175115 ° -121.675463 °	38.176805 ° -121.677893 °	4
DWR ID: DWR_NA0012_01_s_2012_4										
9	0.59	0.59	Earthen Levee	Encroachments	WS	M En	FE : Fences Inspector Comments: Animal corral.	38.180012 ° -121.681943 °	38.180012 ° -121.681943 °	5
DWR ID: DWR_NA0012_01_s_2012_5

Fence along the waterside shoulder.

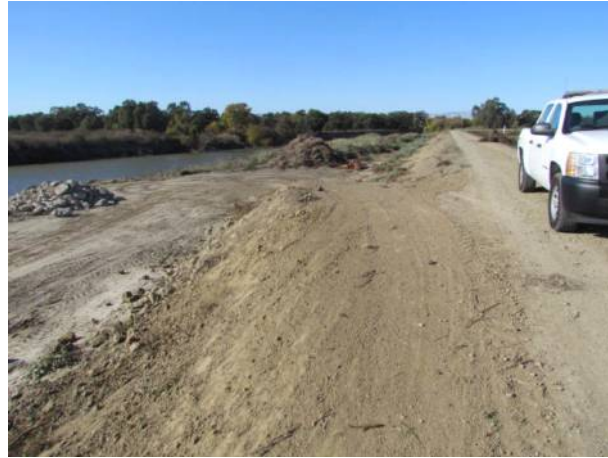
Levee Mile Report Line	6
Start Levee Mile	0.00
End Levee Mile	0.59
Location	Water Side
Category	Earthen Levee
Item	Encroachments
Looking west at fence along waterside shoulder.	
richard_s_20120313_132.jpg

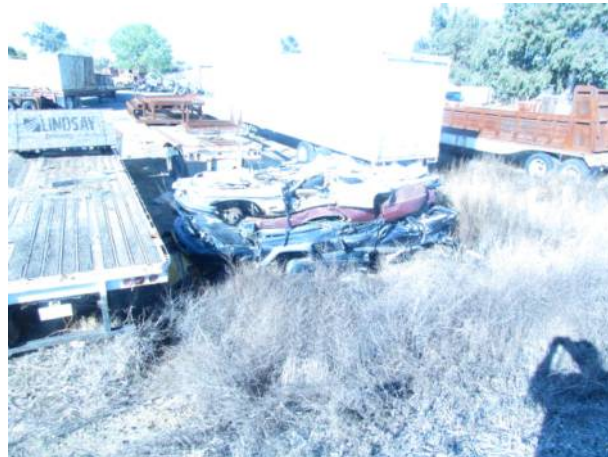
Levee Mile Report Line	7
Start Levee Mile	0.04
End Levee Mile	0.04
Location	Land Side
Category	Earthen Levee
Item	Encroachments
Looking south at crushed vehicles at landside toe.(Spring 2012)	
richard_s_20120507_135.jpg
